110m+ Superyacht – Security Upgrade

Brief

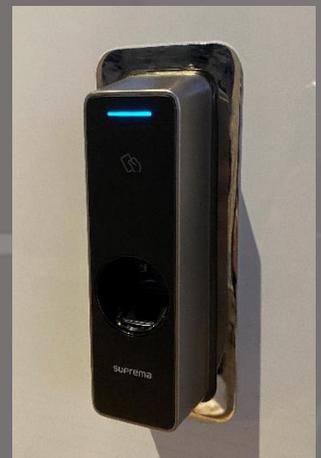
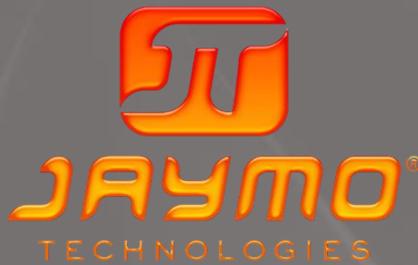
To secure the external doors, Suprema BioReaders were added on each door, requiring additional infrastructure cabling to each ACU location provided from the security BEC's. The ACUs were located as securely as possible to the doors internally so that the cable lengths between the BioReaders and ACU's were within the manufacturer's guidelines. On the internal side of the vessel a push release button was added for exiting the secure door as well as an emergency break glass.

The BioReaders give the vessel the capability to use fingerprints, fobs or NFC to access the vessel securely. The readers and exit buttons release the heavy duty drop bolt lock that was required at each location.
